CONTESSA 32 CLASS ASSOCIATION TECHNICAL PAPER

WATER TANK REPLACEMENT

Technical Paper Name	Water Tank Replacement
Original Contributor	Harry Allaway – “Hurrying Angel”
Edited by	George Isted
Date of Original Creation	December 2007

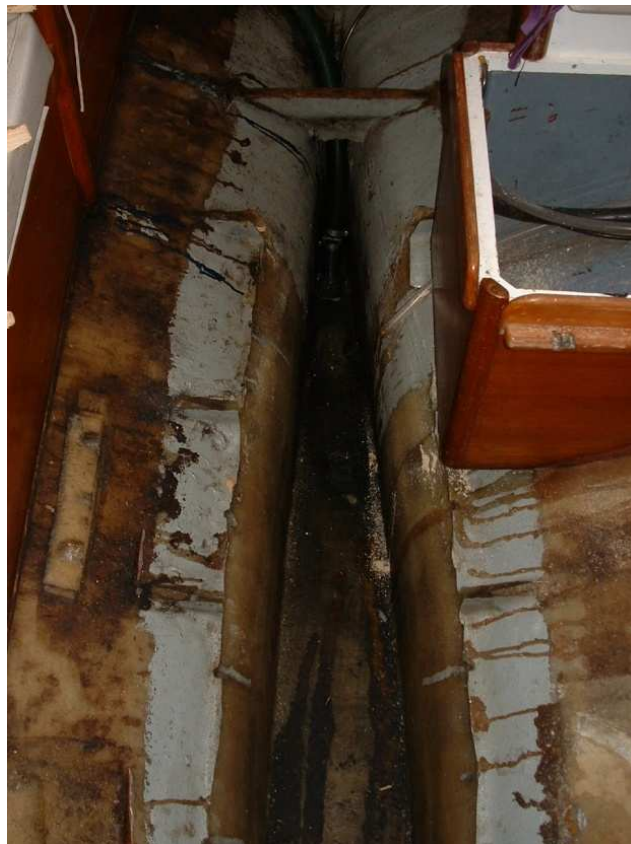
This picture show the empty bilge.

Jeremy's advice sounded quite easy and straight forward until the day work started! The cabin floor was removed to reveal the glass fibre tank. Arrangements had already made to remove the floor with the mast still in place. Undaunted, or perhaps with a little trepidation, work started by attacking the tank with a saw. Three hours later, having cut through the floor bearers and fibre glass, the old tank was released.

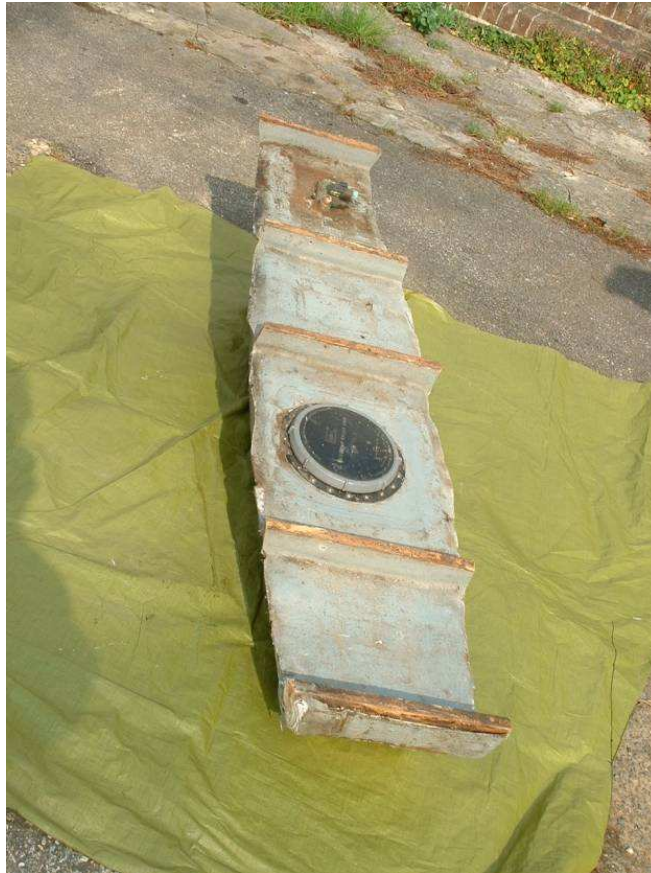
This picture show the tank with the five cut floor bearers.

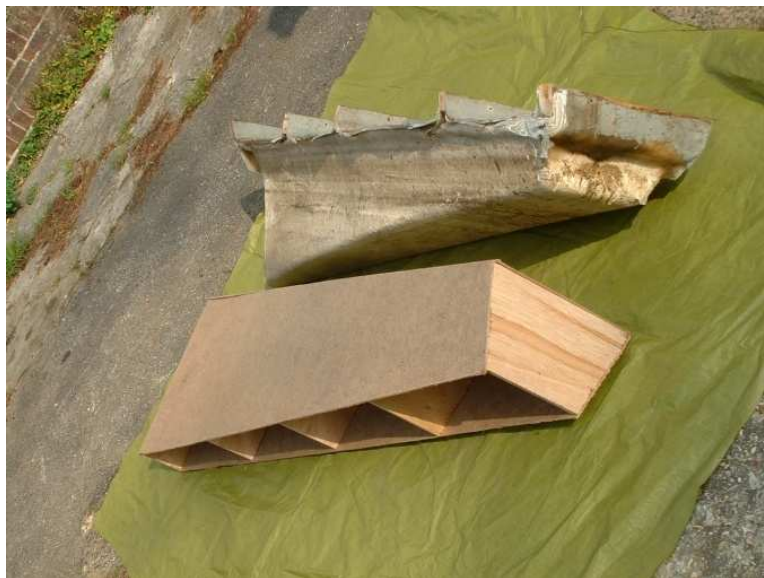
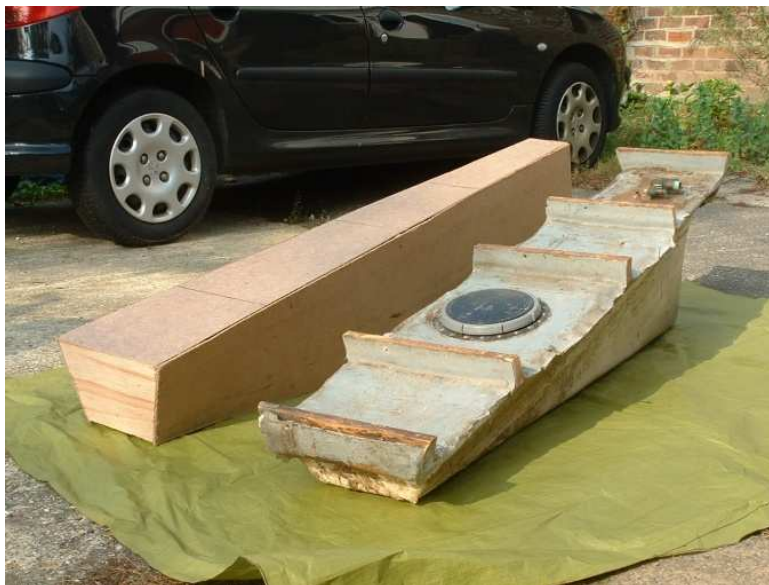
The following photographs try to show the comparison between the old and proposed new tank. This gives approximately an additional two inches in depth.

To gain more space, the second bilge pump pipe, which originally ran under the old water tank, was cut short at the base of the mast. A prototype was then made from hardboard to check that the measurements and design would produce a tank that would fit into the enlarged space.

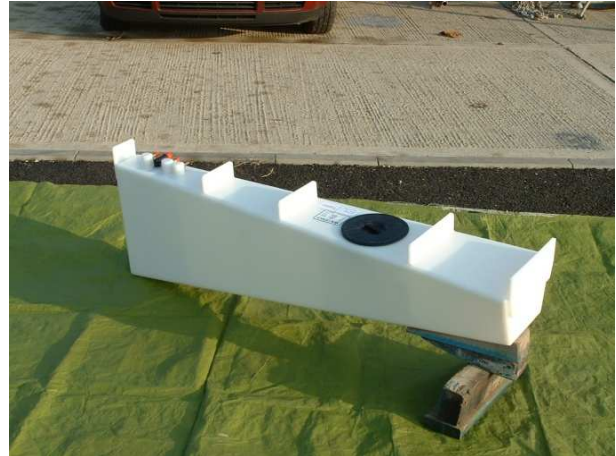
Finally the tank was ready and I collected it from Alton. Eager to check that all the measurements were correct and that it would fit the new tank was temporarily placed into position. I should not have worried. Tek-Tanks had produced the new tank exactly as specified, complete with the flanges to hang the tank on the floor supports.

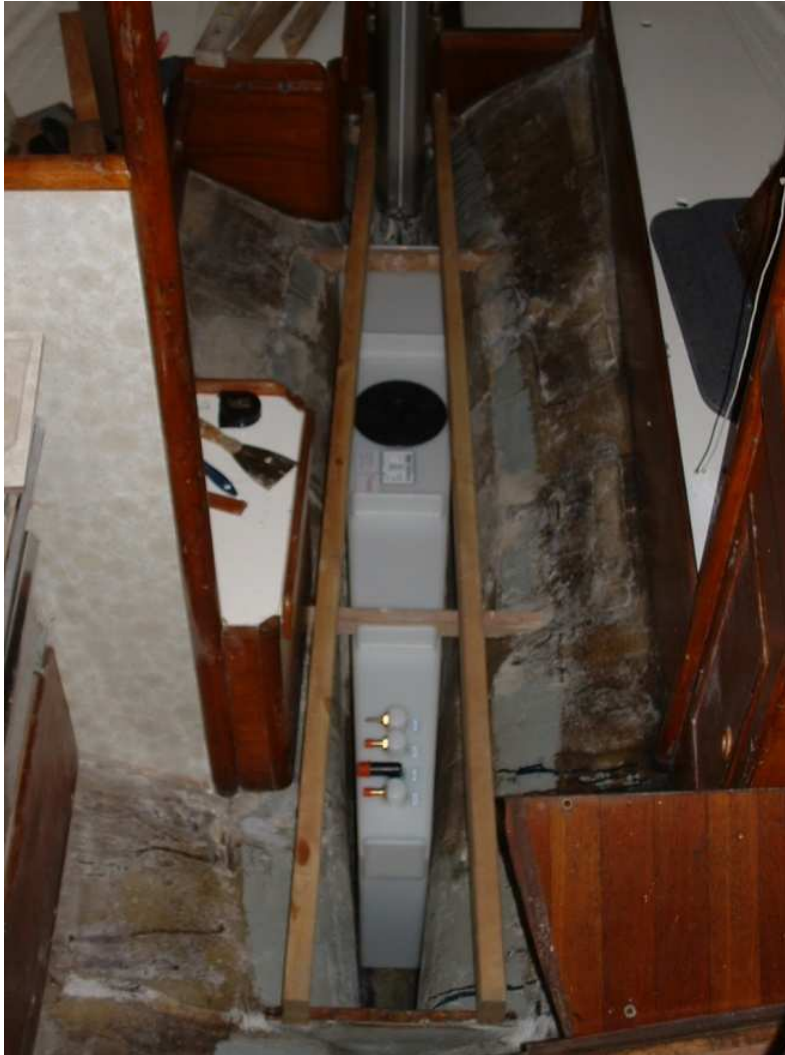
A couple of long lengths of timber were used to ensure the floor supports were level.

With the tank finally in place, the floor supports were constructed and glassed in and left to cure. A couple of long lengths of timber were used to ensure the floor supports were level. The flanges were then drilled and the tank bolted to the supports. The floor was refitted and all the panels put back into place.

When carrying out this repair it is essential to bond over the top of the tank to ensure that the two sides of the hull and tied together so as not to flex under stress.

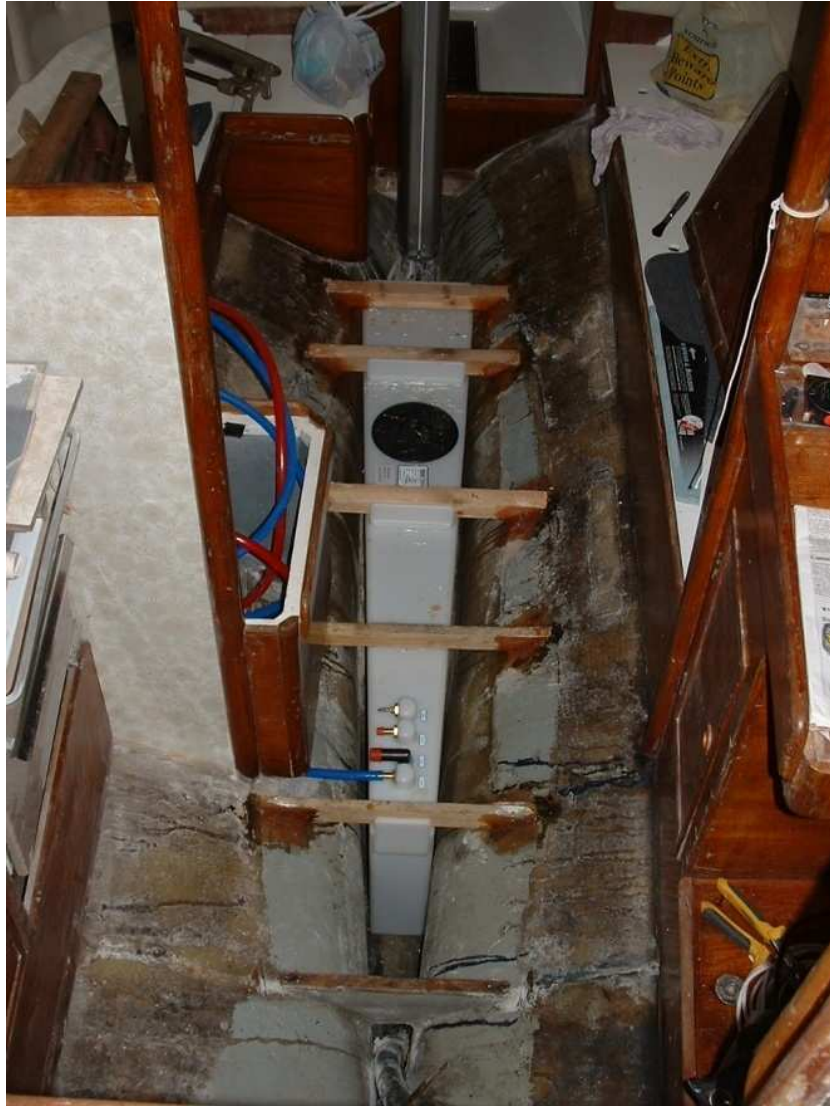
The flanges were drilled and the tank bolted to the supports.
