CONTESSA 32 CLASS ASSOCIATION TECHNICAL PAPER

HOW TO MAKE YOUR CONTESSA SMELL SWEETER

Technical Paper Name	How to make your Contessa smell sweeter
Original Contributor	James Moore – “Katisha”
Edited by	George Isted
Date of Original Creation	November 2009

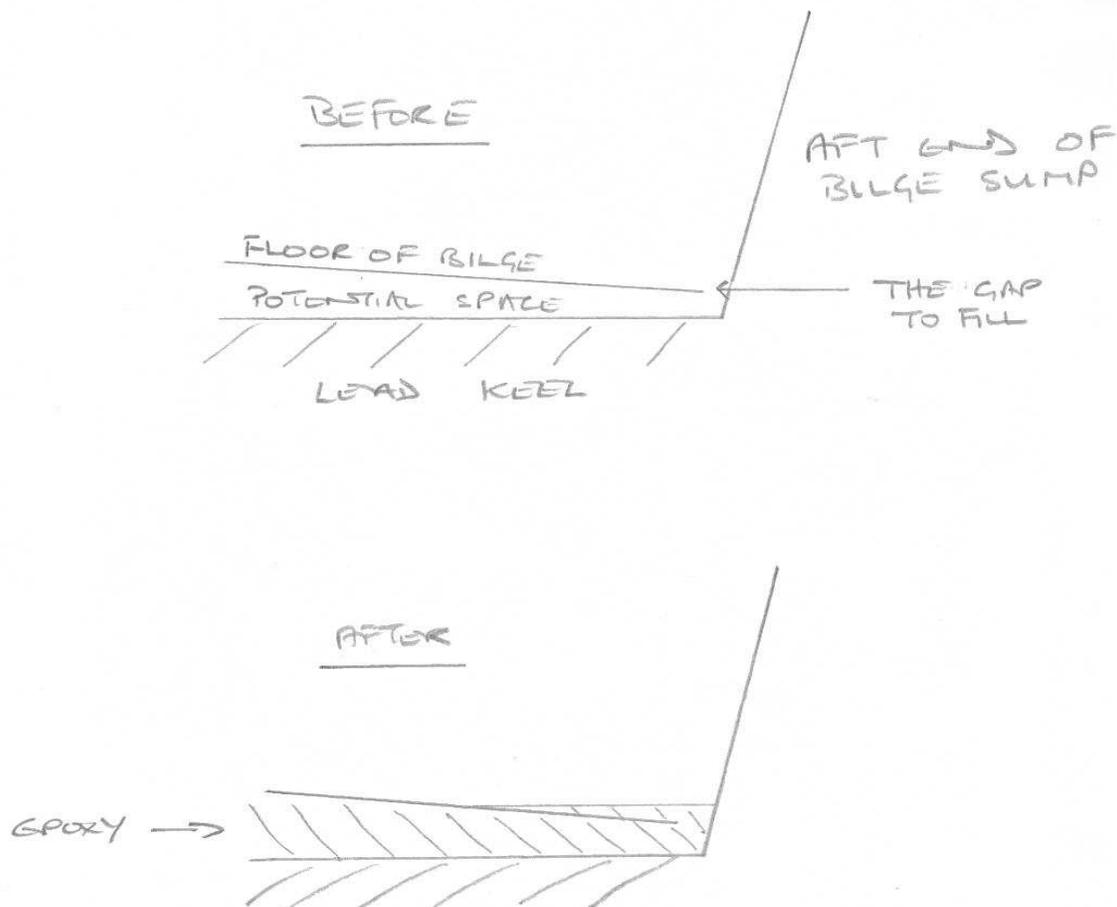
The problem is that there is a small void between the top of the lead keel and the floor of the bilge. There is a communication to this potential space at the aft end of the bilge sump where the floor does not quite close the gap – see diagram. I am not sure if this exists in all the boats but it certainly did in Katisha and others I have seen.

Over the years this space fills with old oil, water, bits of food and other detritus that has fallen into the bilge in the 30 years or more they have been afloat. This slowly turns into a pungent vile mess whose aroma pervades

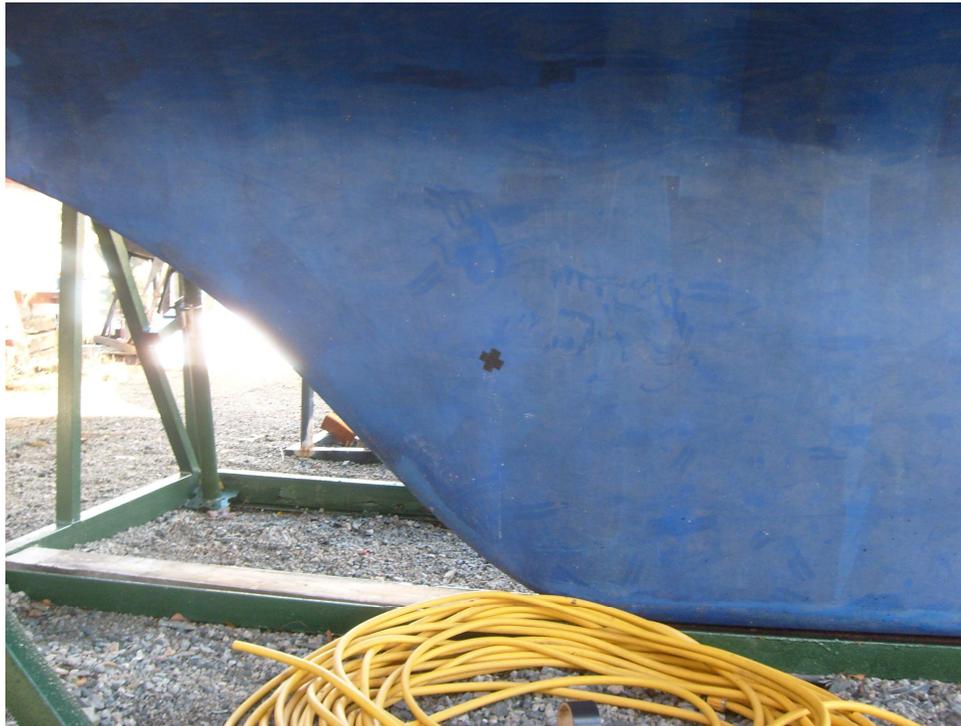
You first have to find the top of the lead ballast. The way to do this is to tap with a small hammer from the bottom of the keel upward. At about two feet from the base of the keel it will stop sounding "dead" and sound hollow – this is the top of the lead. This is where to drill the hole – see photo – X marks the spot! We only drilled one hole – I believe others have drilled more – but I don't really see the point.

We drilled a 15mm hole and as we got through the GRP we released a foul cocktail that was clearly the cause of the smell. Once this had run out we could see in the bilge where it had got in as the gap was revealed.

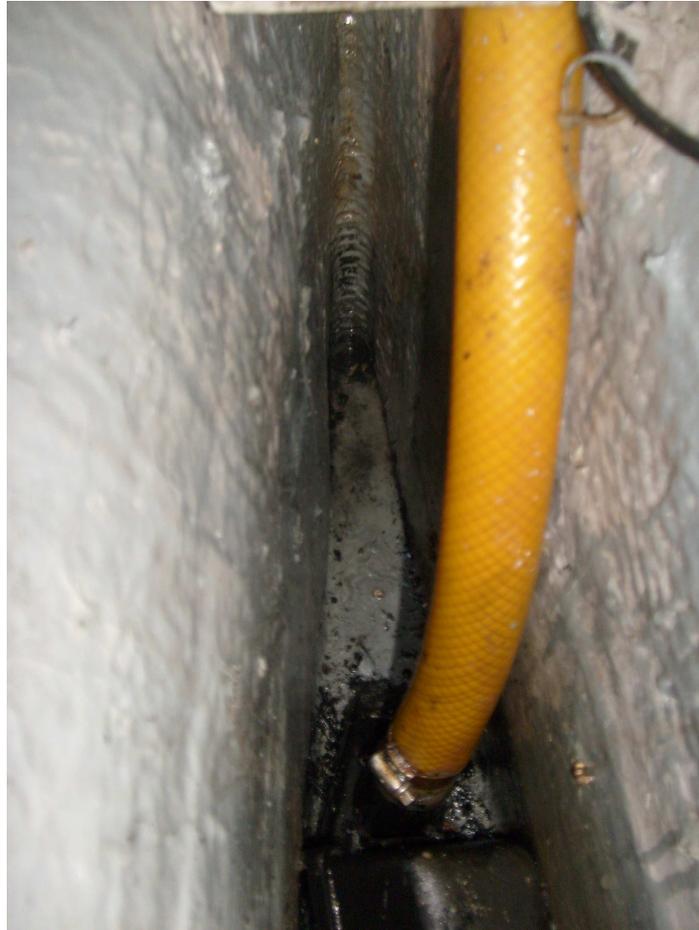
Having let the space dry out for another week or two we then poured epoxy down the hole in the bilge until it ran out of the hole in the keel. We made the mixture quite weak initially so that it would flow and not set too quickly. Once it appeared at the forward end we taped over the hole and continued pouring mixture in the top until no more would go in and the hole in the bilge space was completely filled over – see photo.

We then made good the hole in the keel and faired it over. After a season of sailing I can safely say the bilge no longer smells and that the exercise has been a success. I still haven't managed to get my wife to sail – but maybe that's a good thing.
